Barrier test certificate for: Spectator Seating Ltd.

Job ref: BT/ 1989 /17
 Barrier ref: Barrier prototype
 Details: 1.0kN/m test (Guide to Safety at Sports Grounds barrier type 6)

Job ref: BT/ 1989 /17
 Barrier ref: Barrier prototype
 Details: 1.5kN/m test (Guide to Safety at Sports Grounds barrier type 7)

Job ref: BT/ 1989 /17
 Barrier ref: Barrier prototype
 Details: 2.0kN/m test (Guide to Safety at Sports Grounds barrier type 4)

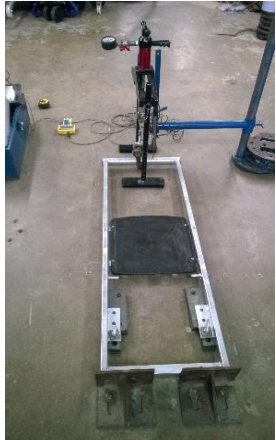
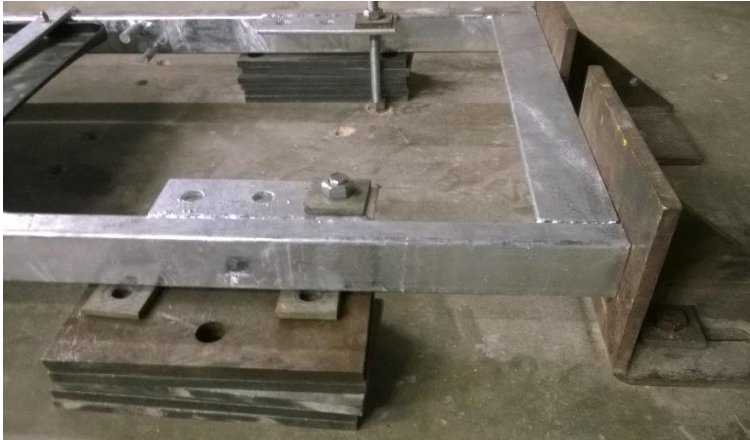
Barrier prototype secured to the concrete slab through bottom hole with M12x75 shield anchor. Bottom of the barrier was secured to steel plates.

Height of barrier was taken as 0.9m, which is the height from the seat pan to the handrail.

The deflection was measured at 60mm away from the mid span.

No defects were observed during testing.

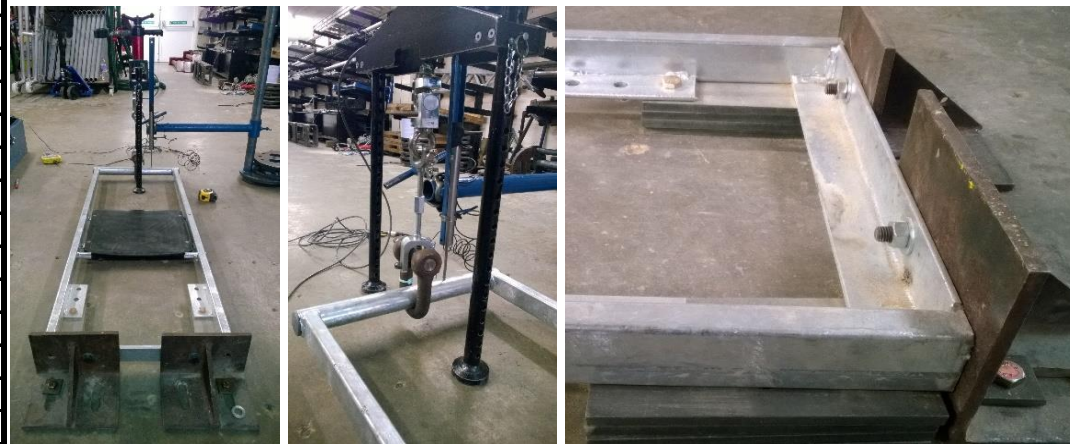
Barrier prototype secured to the concrete slab through bottom hole with M12 x 150mm concrete screws (effective depth of 100mm with packing). Bottom of the barrier was secured to steel plates. Height of barrier was taken as 0.89m = 1.39m (total height of barrier) - 0.5m (assumed height of concrete step from client). The deflection was measured at 60mm away from the mid span.

No defects were observed during testing.

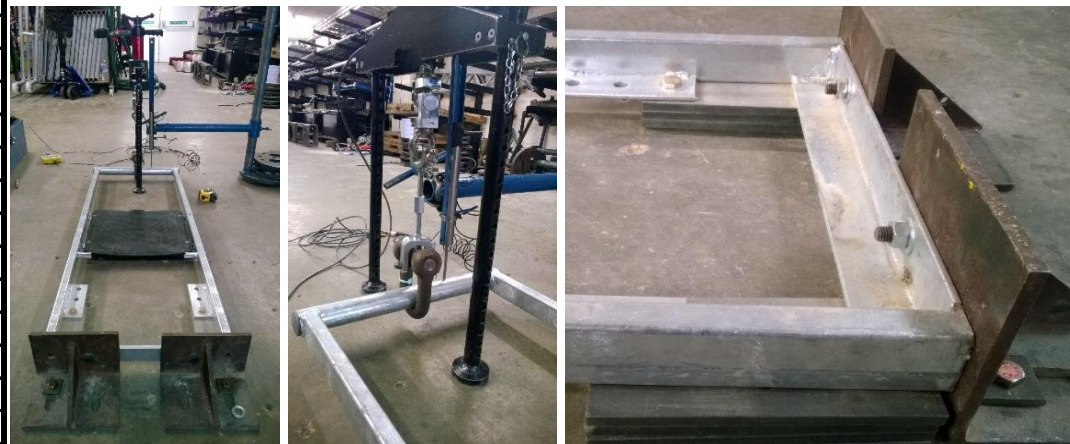
Barrier prototype secured to the concrete slab through bottom hole with M12 x 150mm concrete screws (effective depth of 100mm with packing). Bottom of the barrier was secured to steel plates. Height of barrier was taken as 0.89m = 1.39m (total height of barrier) - 0.5m (assumed height of concrete step from client). The deflection was measured at 60mm away from the mid span.

No defects were observed during testing.
